**A REPORT  
ON THE  
GEOTECHNICAL  
INVESTIGATION**

**FOR THE PROPOSED  
OUYEN RECREATIONAL LAKE  
VIA NORTH WEST ROAD  
OUYEN**

**Report N<sup>o</sup>: 3120155**

**PROJECT** : Ouyen Recreational Lake  
OUYEN

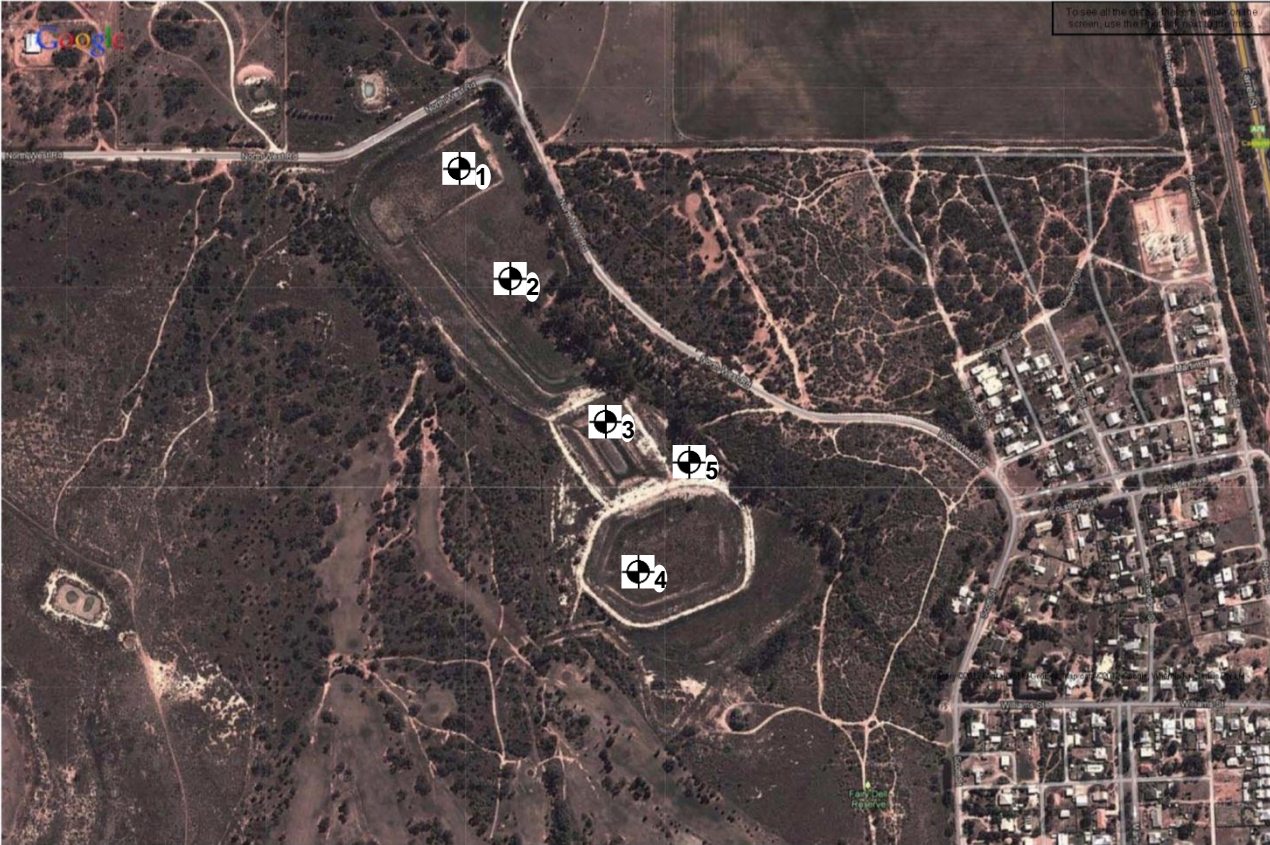
**LOCATION OF TEST SITES: RECREATIONAL LAKE, VIA NORTH WEST ROAD, OUYEN**

**Denotes Test Holes**

The fieldwork was carried out on 23 October 2012 by mechanically augering five bore holes at the approximate locations as shown on the attached site plan.
